## DECISION-MAKING: DAM DECOMMISSIONING AS AN ALTERNATIVE TO REGULATION

**Glauco G. Dias\***, **Victor R. F. Oliveira\***, **André. S. O. Furtado\*** and **José M. Colobarolli†**

The Gegraf dam is located on the highway MG-164, km 04, Povoado Água Limpa, in the municipality of Itapeçerica, Minas Gerais state, Brazil.

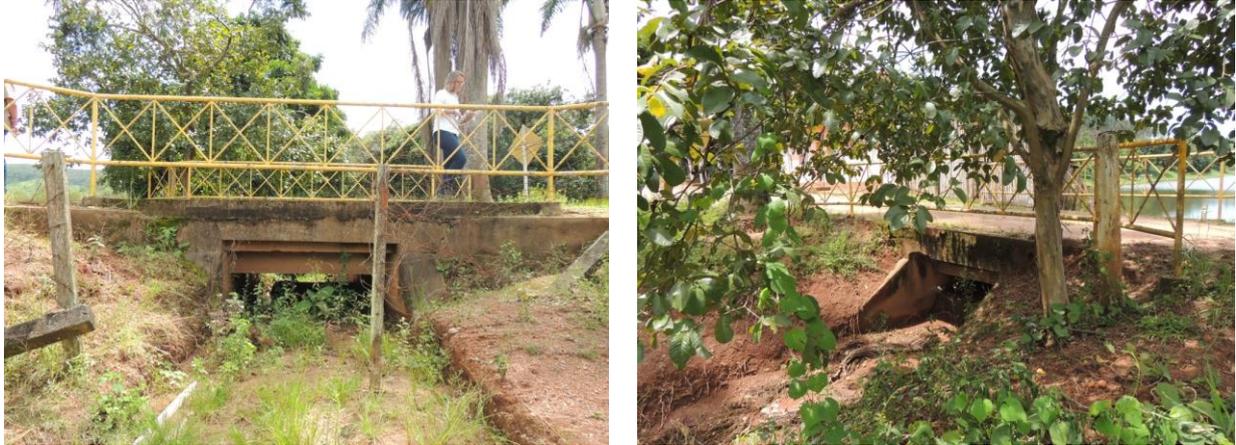
According to a study by the company Azurit Engenharia<sup>3</sup> in March 2007, the spillway is undersized and does not meet the maximum outflow established in the project, incurring in risk of overtopping. To adjust the discharge capacity it would be necessary to increase the size of the spillway.

Figure 2: Gegraf Dam Spillway

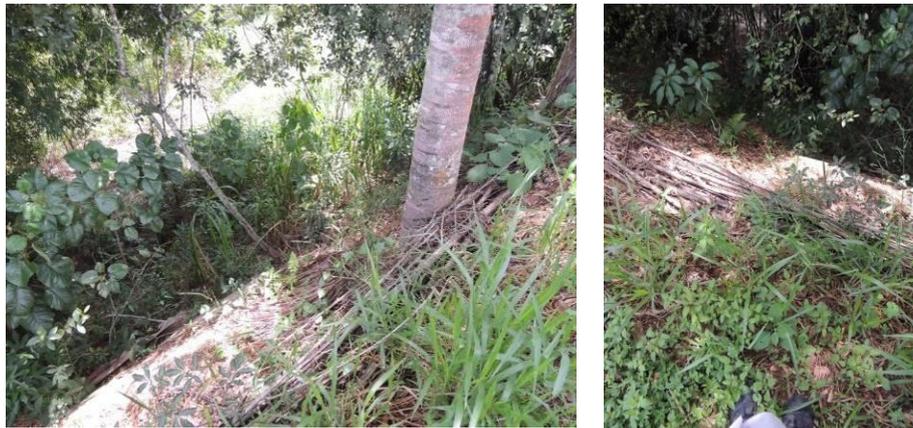
The downstream slope inclination is extremely high for an earthfill dam, compromising the stability and resulting in cracks, landslides, erosions or seepage.

Figure 3: View from the top of the downstream slope

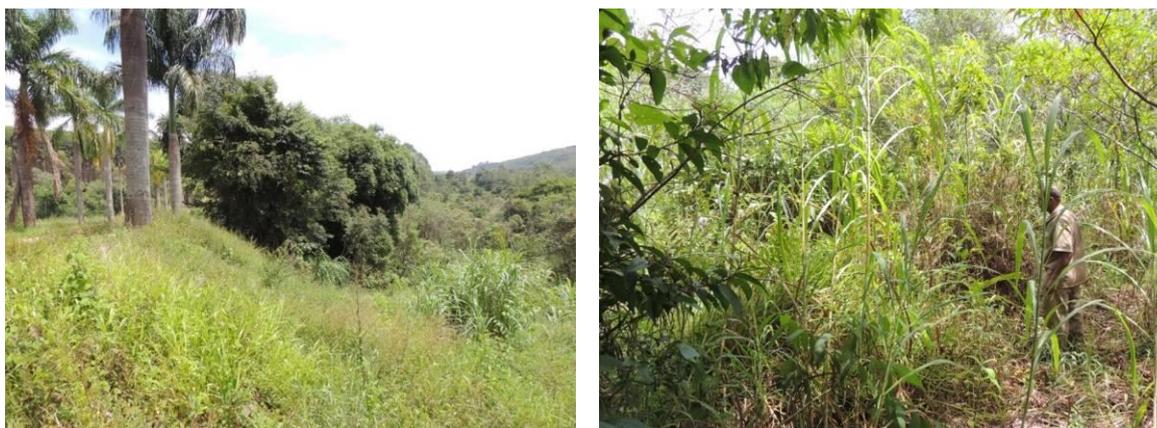
Vegetation has completely taken up the downstream slope in such a way that it was not possible to inspect the toe region of the structure. By means of a drone flight performed by Enemax, it was possible to identify water accumulation at the toe of the dam. This region was not known by management staff due to the inexistence of monitoring and maintenance routine until that date.

Figure 4: High vegetation in the downstream slope

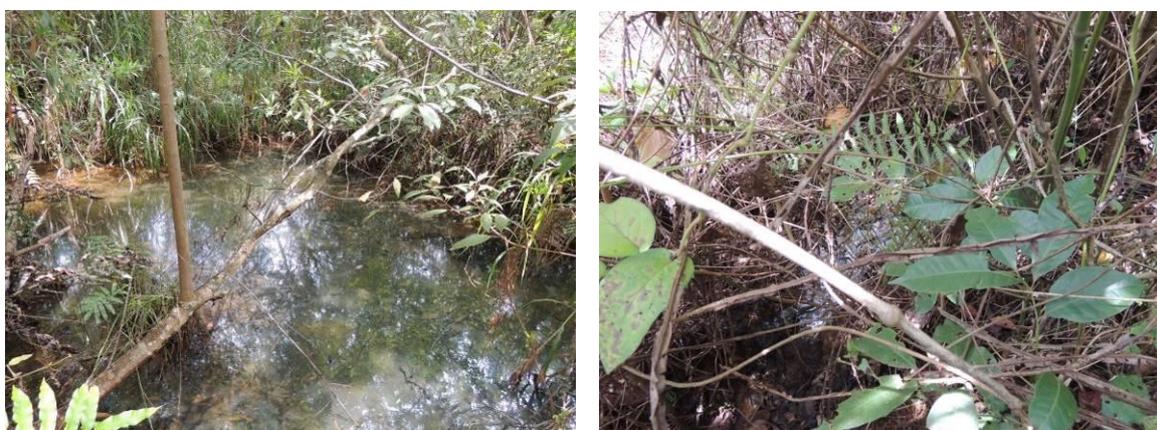
Figure 5: Water accumulation at the toe of the dam

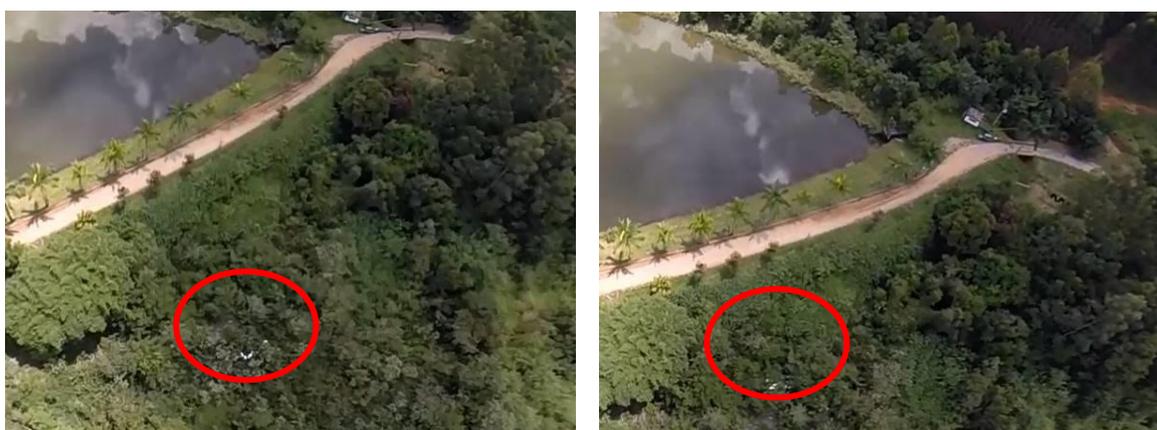
Figure 6: Water reflection observed in during the drone flight

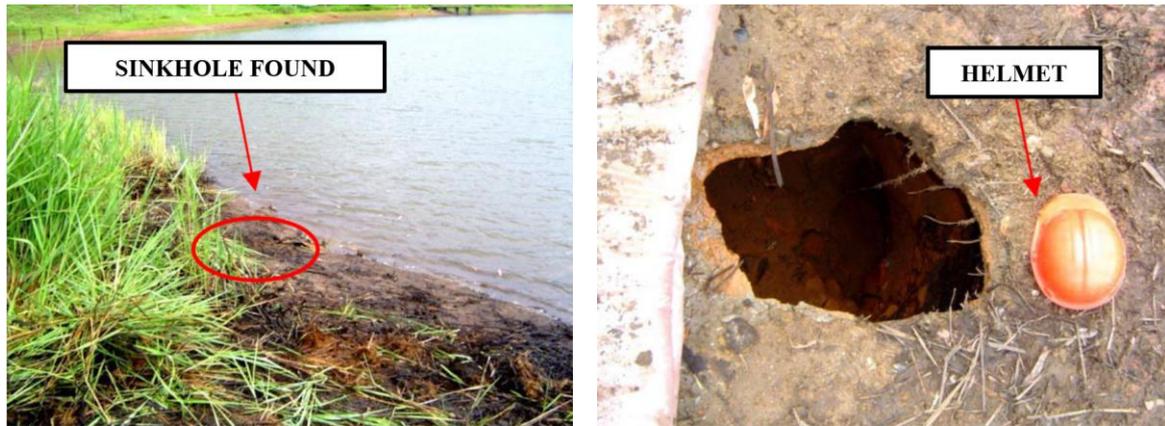
In previous records, the occurrence of internal erosion was reported in 2006, which indicates that the lack of maintenance already occurred at that time. According to a dam safety report made by Azurit Engenharia<sup>4</sup> in May 2006, in order to stop the opening, all the saturated earth was removed and the site was rebuilt with stone and compacted earth. Finally, the area was covered with organic soil for posterior revegetation with grass.

Figure 7: Location and dimension, respectively, of the sinkhole found in the upstream slope of the Gegraf dam

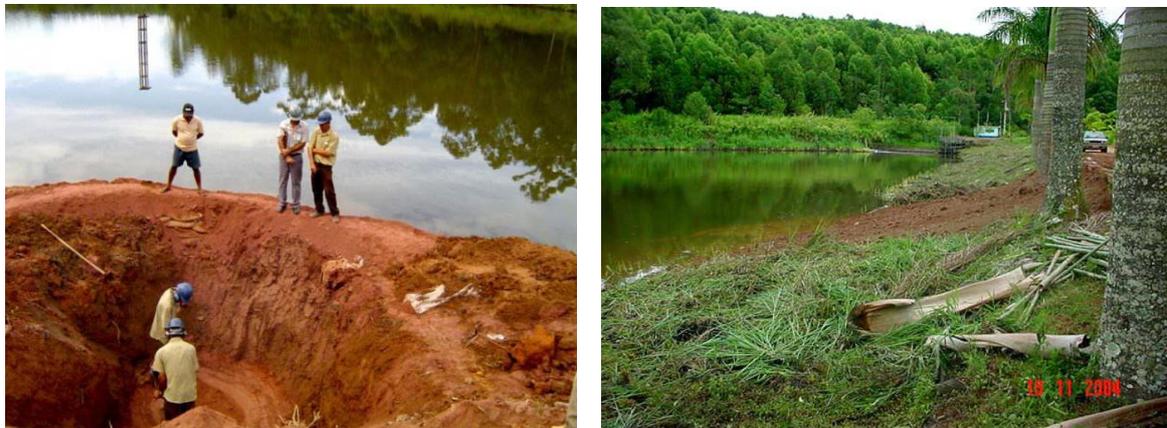
Figure 8: Compaction of clay material and protection of the affected site with organic soil
