## DECISION-MAKING: DAM DECOMMISSIONING AS AN ALTERNATIVE TO REGULATION

**Glauco G. Dias\***, **Victor R. F. Oliveira\***, **André. S. O. Furtado\*** and **José M. Colobarolli†**

The Gegraf dam is located on the highway MG-164, km 04, Povoado Água Limpa, in the municipality of Itapeçerica, Minas Gerais state, Brazil.

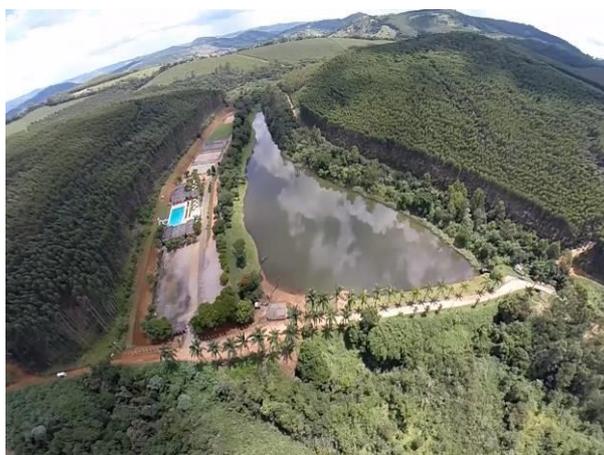
Figure 1: Aerial view of the reservoir of the Gegraf Dam. In the right margin is located the Gegraf Sports Club

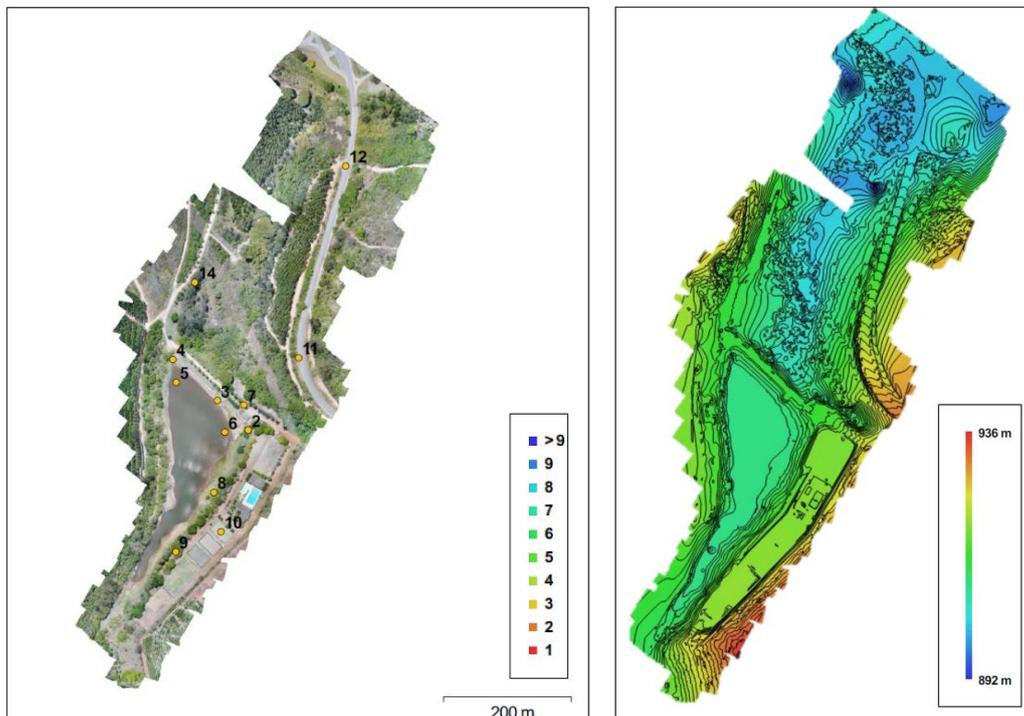
Figure 9: Location of ground control points and contour lines obtained and used for the project

The project consisted in the creation of a breach transversal to the dam, connecting upstream and downstream, in alignment of the axis of the outlet basin of the internal drainage. Through this gap the stream will flow again.
